Repair of Line With FRP Piping

Location: West Texas Water Supply - Odessa, Texas

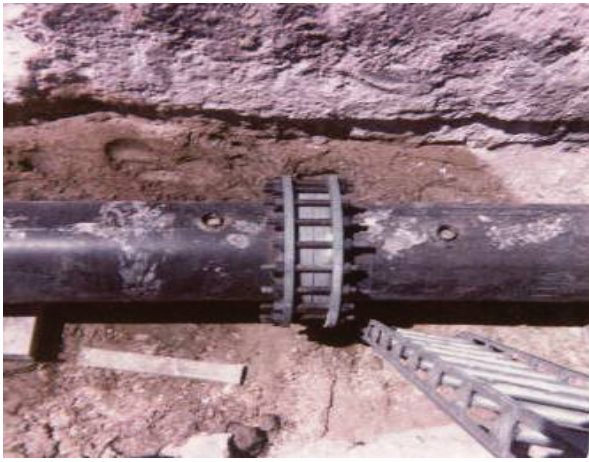
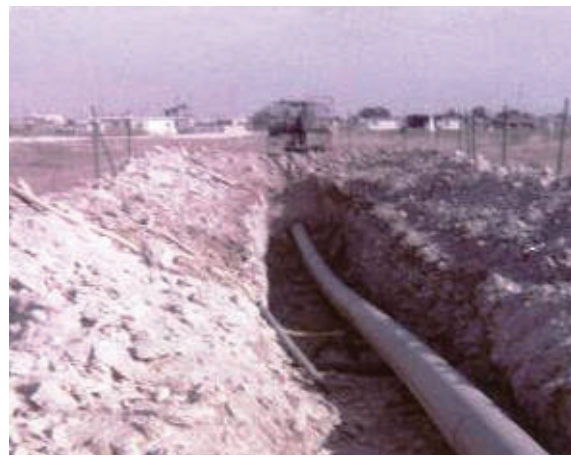
Application: Steel reinforced concrete pipe carrying brackish water was rupturing due to corrosion and water hammer. Grouting polyester piping inside the existing line eliminated the problem.

Product: 17,200 feet of 16" Fiber Glass Systems FRP polyester was used in the Unisert IT3 multi-wall system.

Features & Benefits: FRP piping was a cost effective repair. The pipes smooth bore provided flow equal to steel reinforced concrete pipe. Fiberglass pipe's corrosion resistance provides a long service life.

The pipes flexibility allowed it to be pulled around miters in the existing pipe, resulting in fewer fittings and a faster installation.
